Manhole Inspection Summary

Manhole # S31QQ_009MH

Inspection ☐ Is Incomplete Rating: **3) Fair**

Location Address: **410 26TH ST**

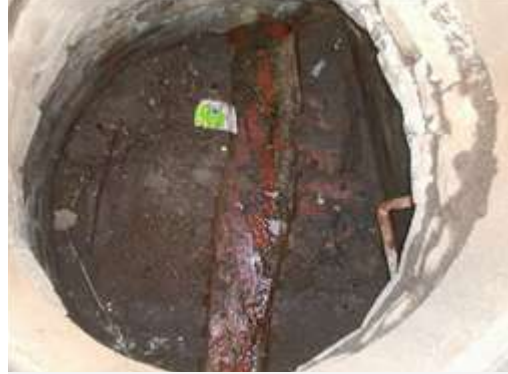
Top View

Corroded steps. Evidence of surcharge - Bench debris.

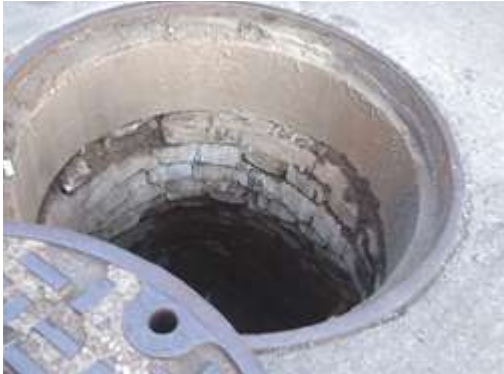
Defect

Frame leaks. Adjustment deterioration, loose brick and infiltration. Corbel and Barrel infiltration - other side.

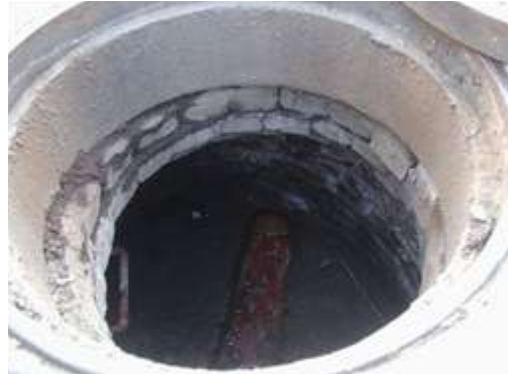
Defect

Frame leaks. Adjustment deterioration, loose brick and infiltration. Corbel and Barrel infiltration.

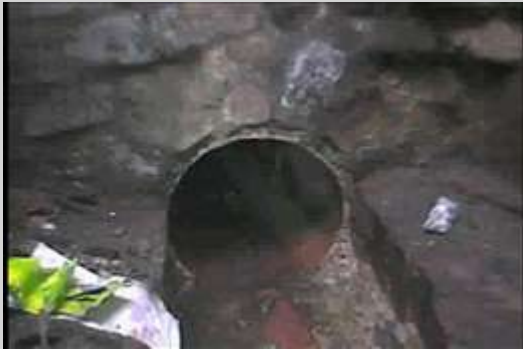
8 in. Circular Gravity Sewer Pipe Out @ 12 O'Clock

Infiltration: **Evidence** Pipe Seal Cond: **Unknown**
